# 2-D AND 3-D RESISTIVITY FOR LOCATING VOIDS BENEATH HIGHWAYS; THREE CASE STUDIES

*Richard W. Hammack*

# Limestone Quarry, Lancaster, PA

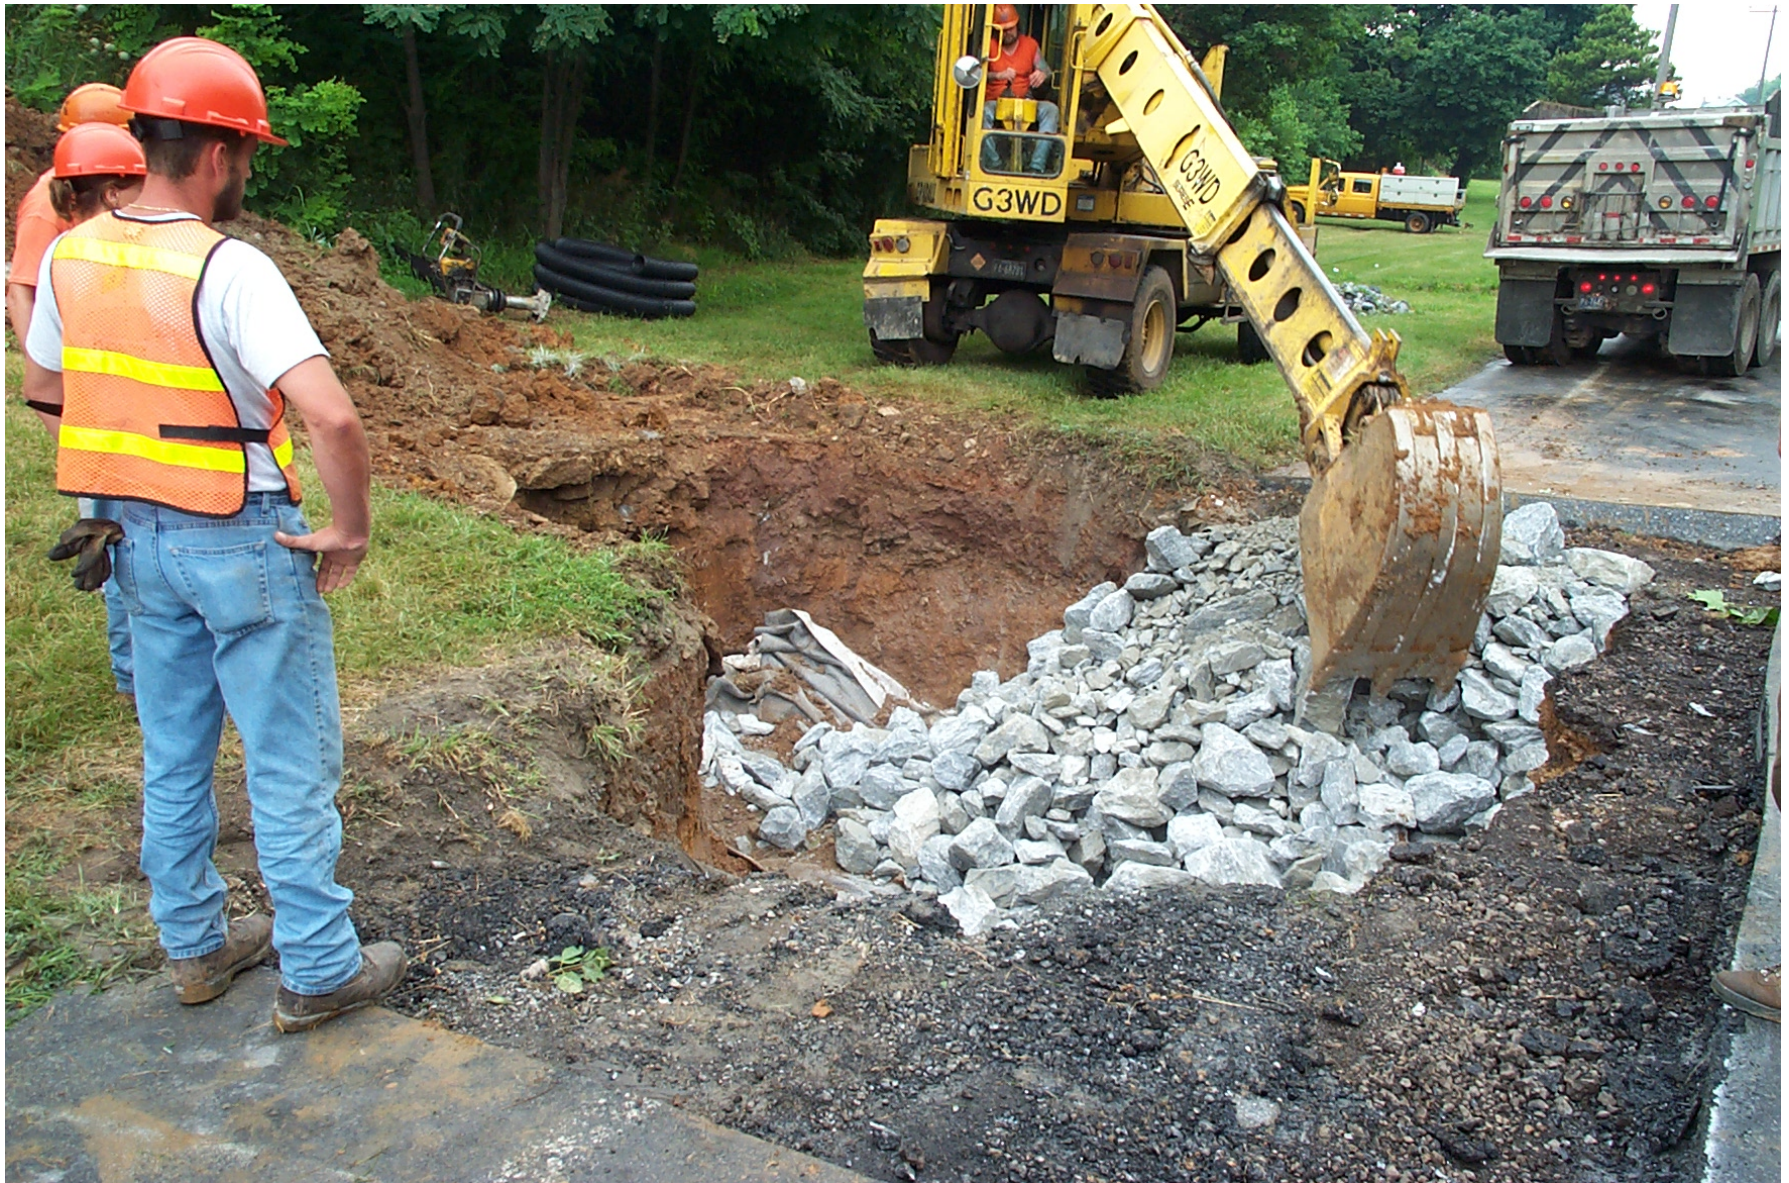
Waterfall 5-3-00

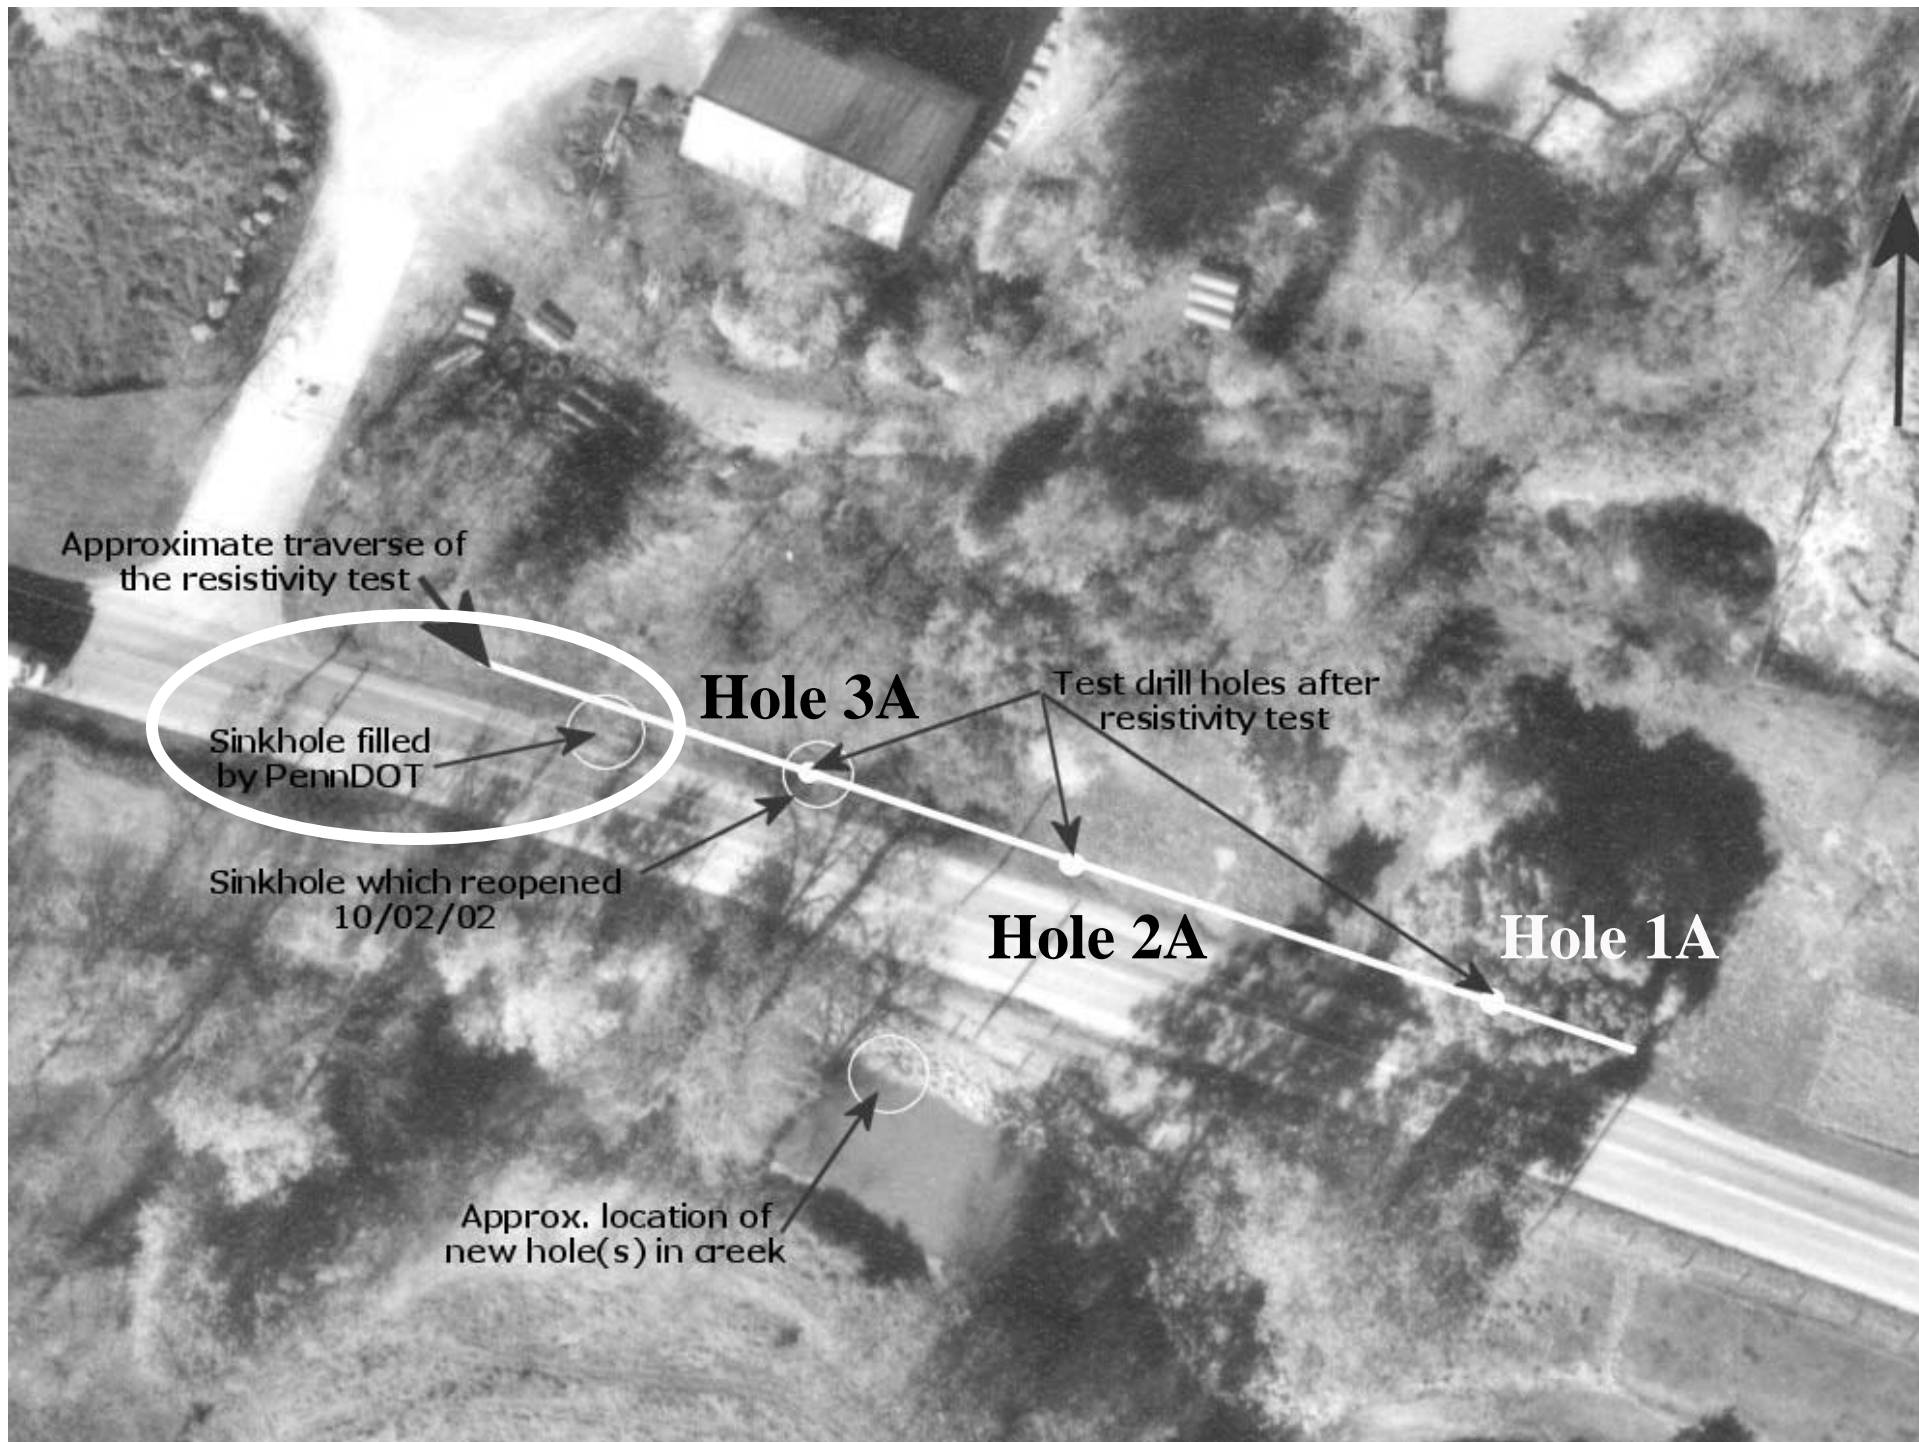
PennDOT filled sinkhole at edge of road

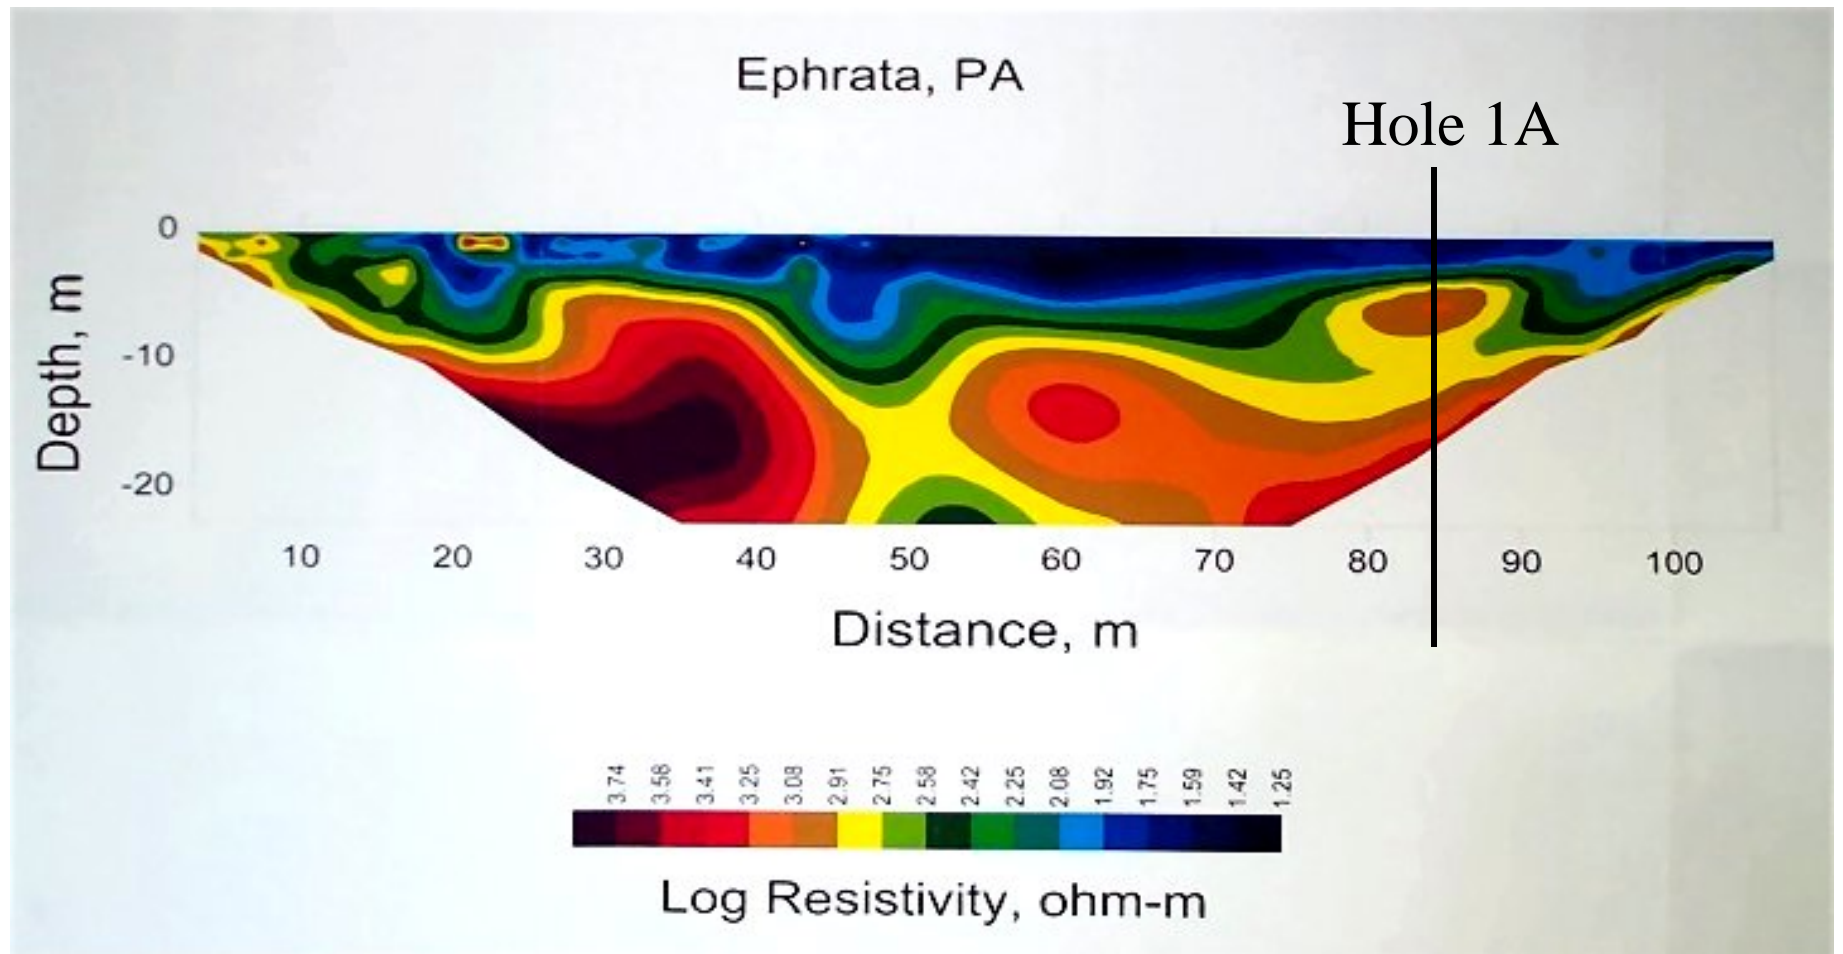
### Resistivity test results – July 2002

Results show traverse line running west to east (left to right). Drilled test holes 9-17-02 along the traverse line at about 35 m, 61 m, and 85 m mark to investigate potential void areas (shown by darker red areas).

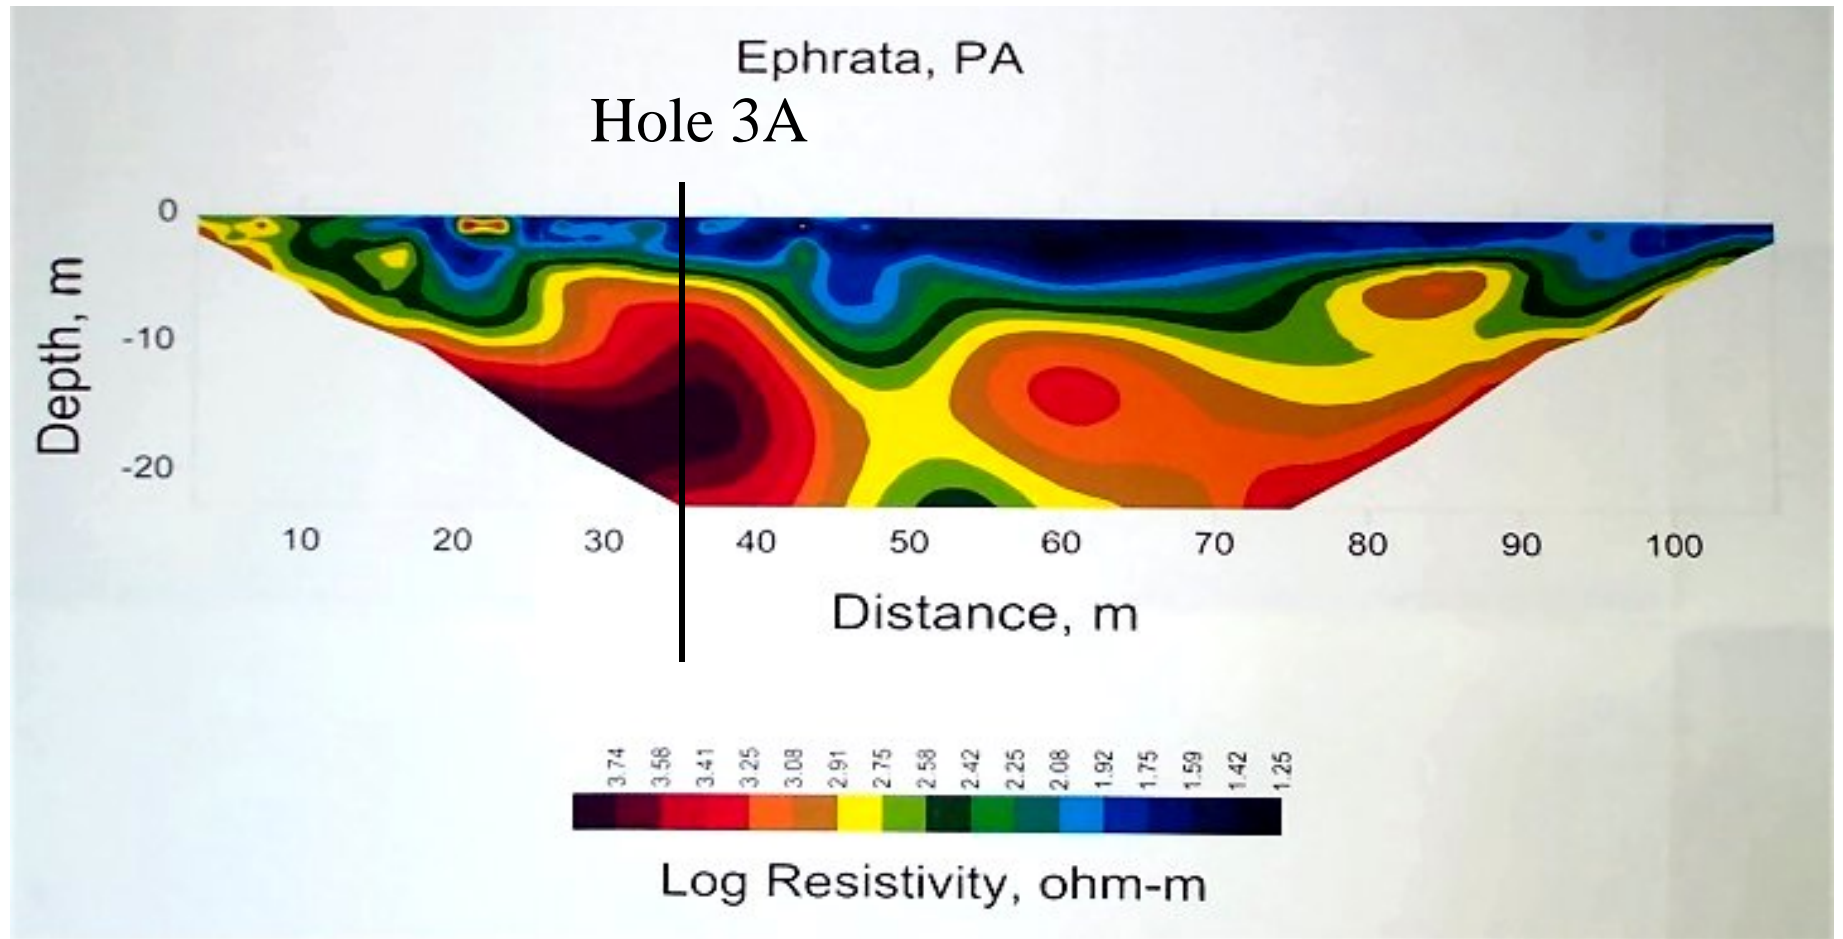
**Hole 3A log – drilled at about 35 m mark (westernmost hole) (Sept 2002)**

- 0-12 clay
- 12-22 rock (hit water at 22')
- 22-47 nothing – drill bit moved through this area very easily.
- 47-60 rock

While drilling this hole, the driller spotted a small (~3") catfish laying in the mud around the hole. The fish had apparently been “blown out” of the hole during drilling. After completing the hole, a second small catfish was found next to the hole.

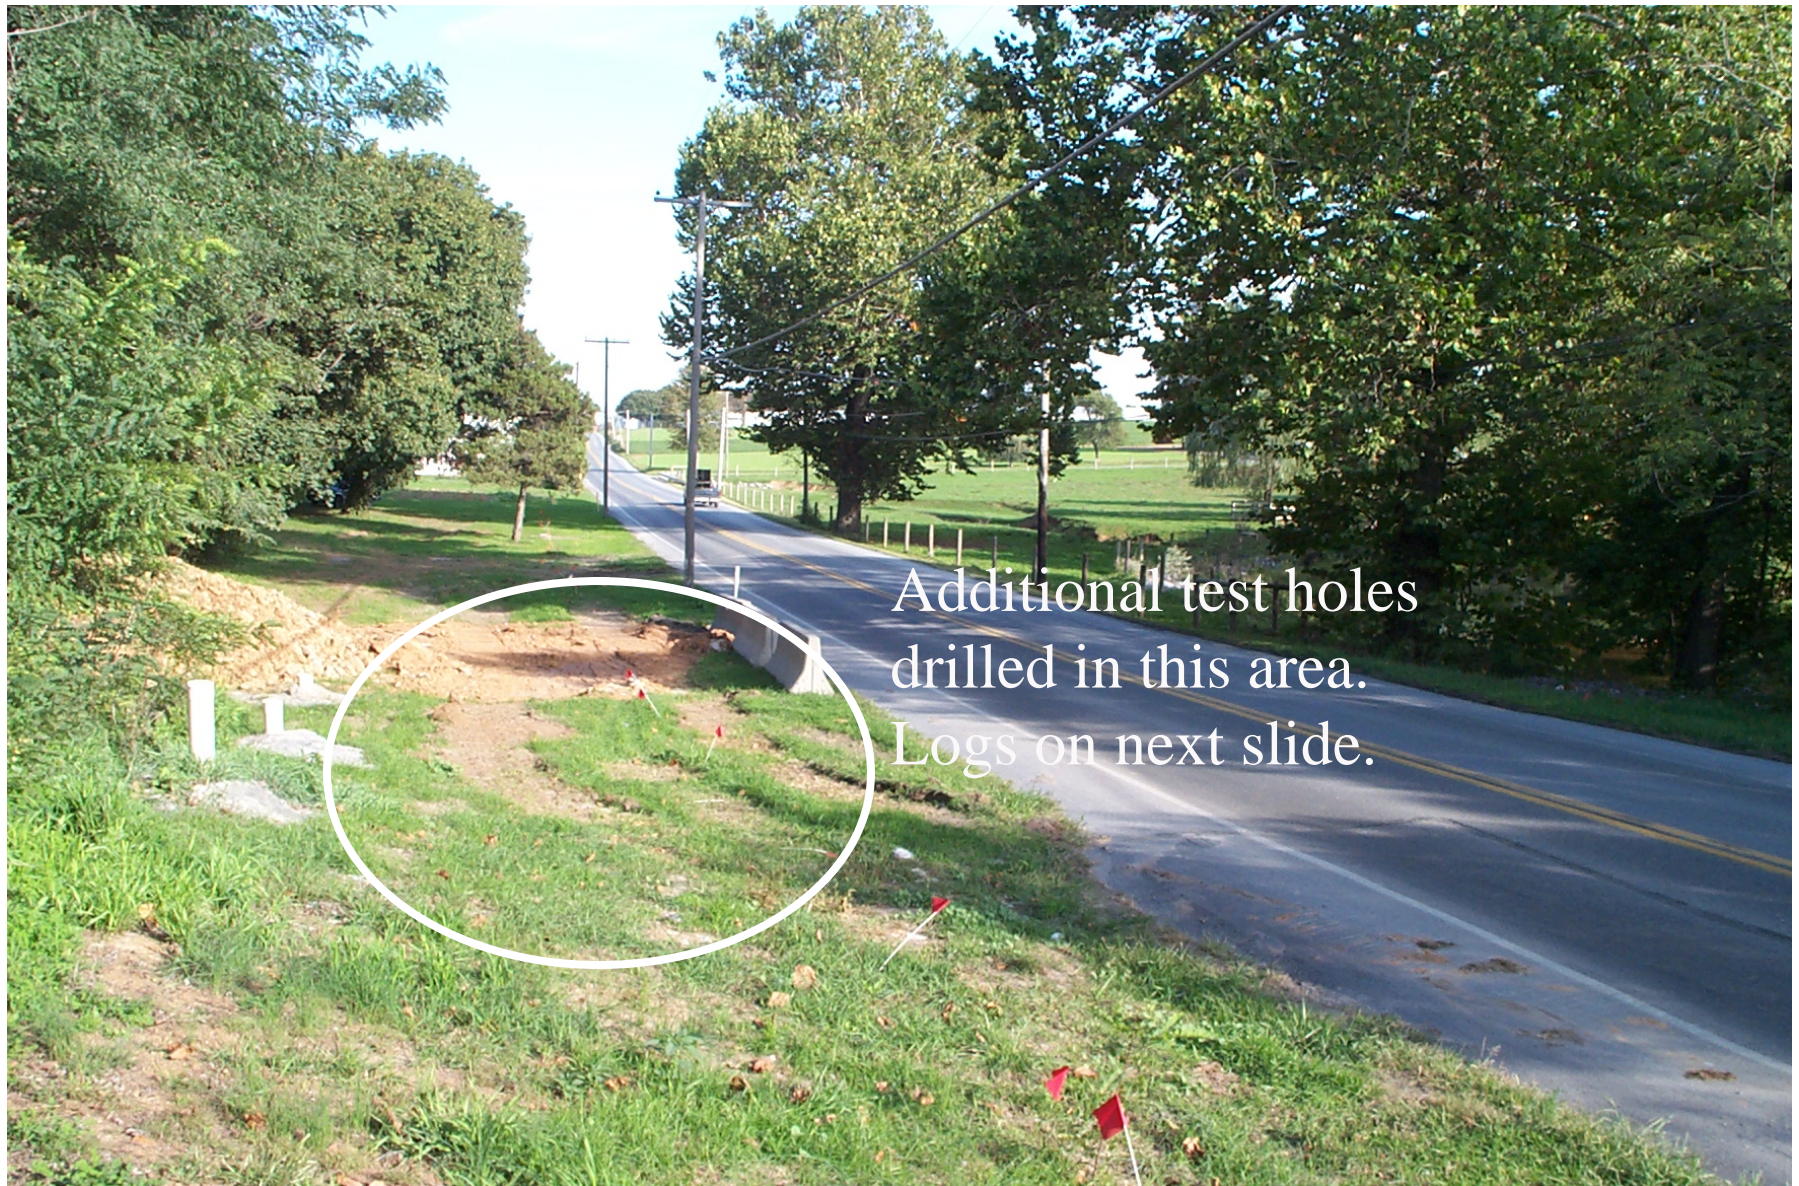
Additional test holes  
drilled in this area.  
Logs on next slide.

Looking east on Martindale Road: resistivity line shown by red flags.  
Dirt area is where sinkhole reopened. (August 2002)

Holes drilled in late 2002 as further investigation on size of potential void on west end of the resistivity test.

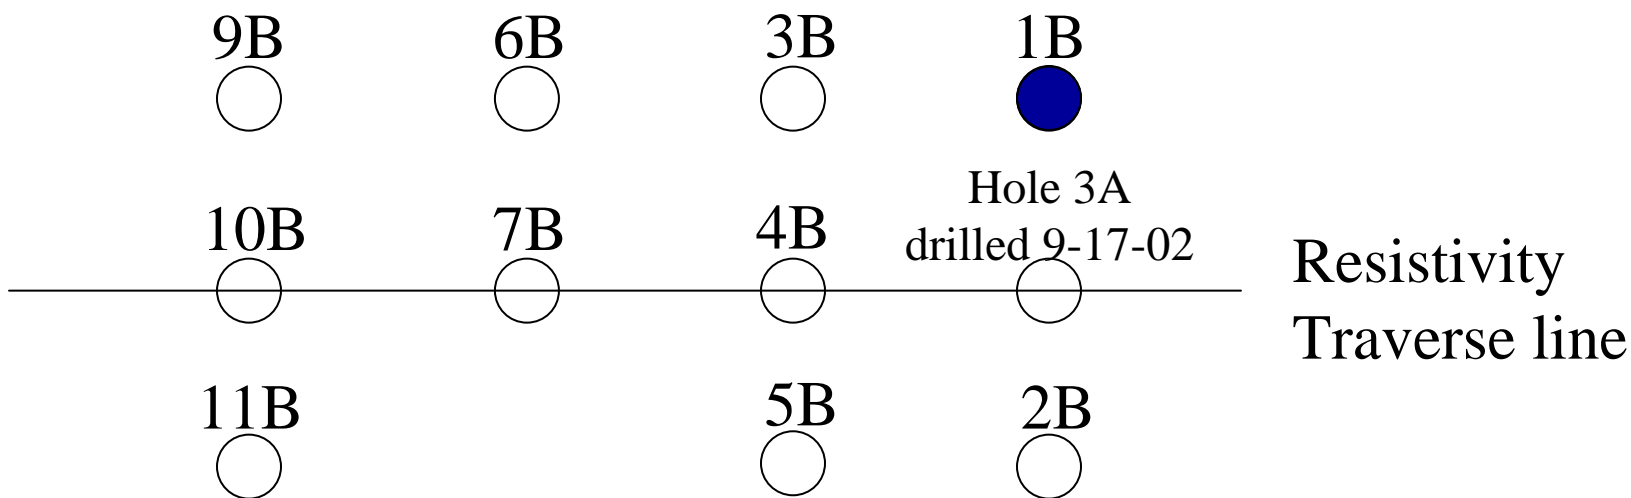
**Hole 1B – 60’ deep**

0-25      clay  
25-58    open  
58-60    solid

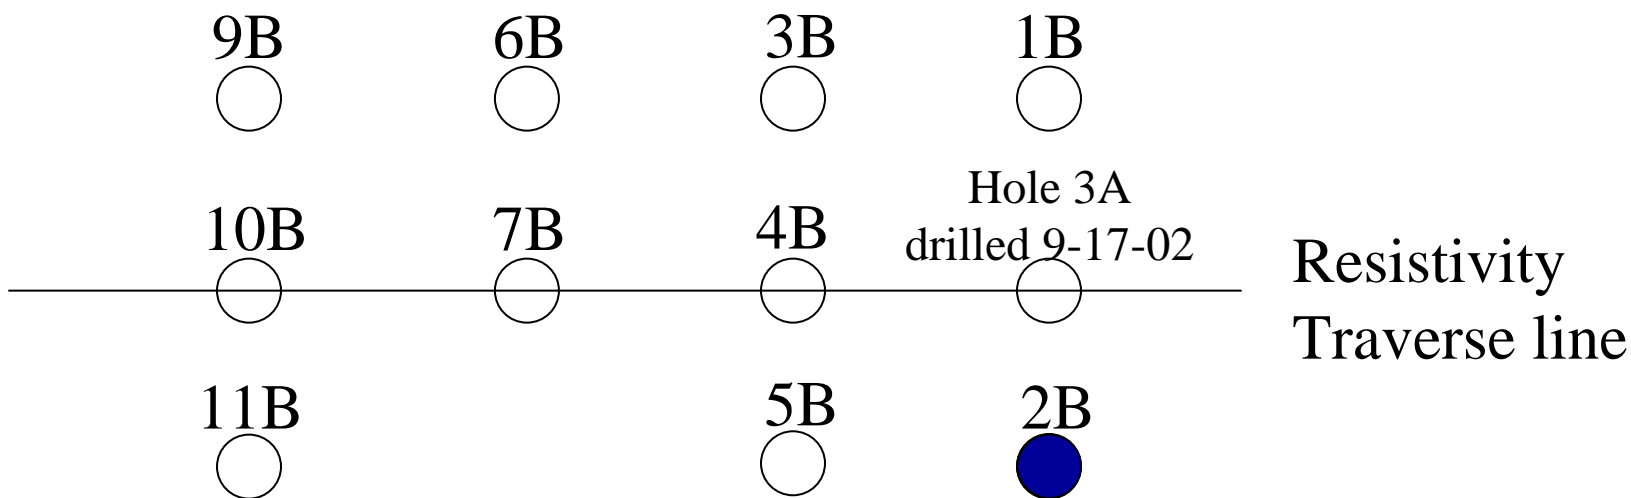
**Hole 2B – 60' deep**

0-15	dirt/clay
15-28	solid
28-30	dirt/loose
30-34	solid
34-36	broken
34-60	solid

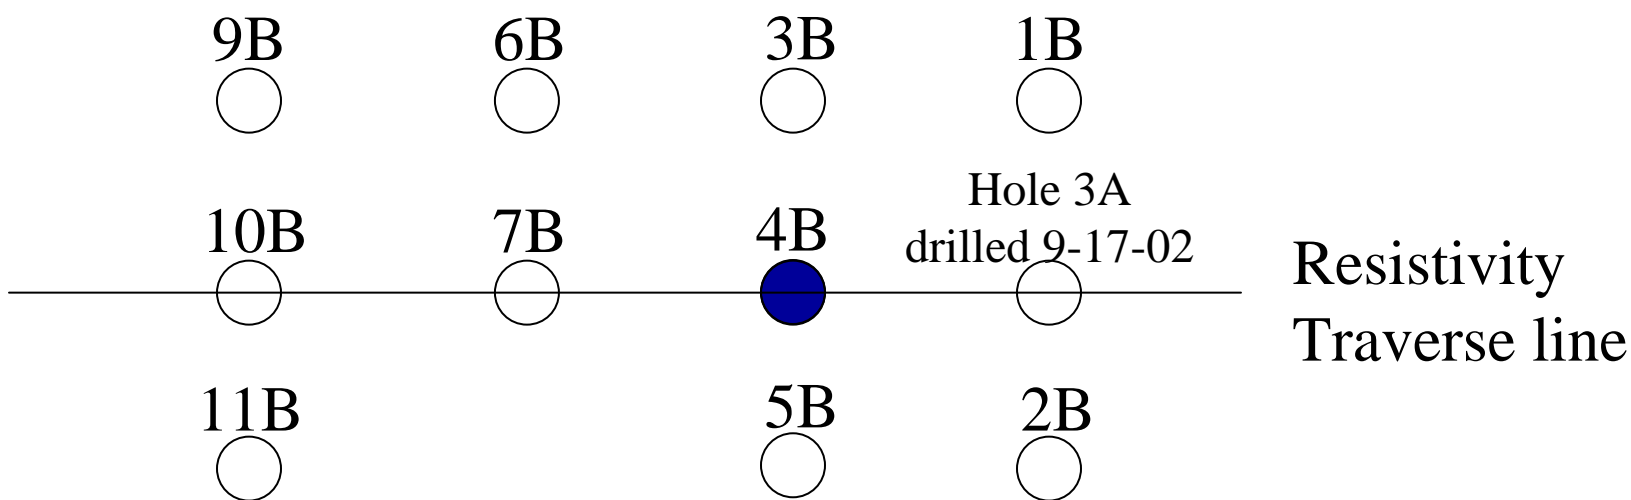
**Hole 4B – 60' deep**

0-15	clay
15-26	solid
26-36	open
36-60	solid

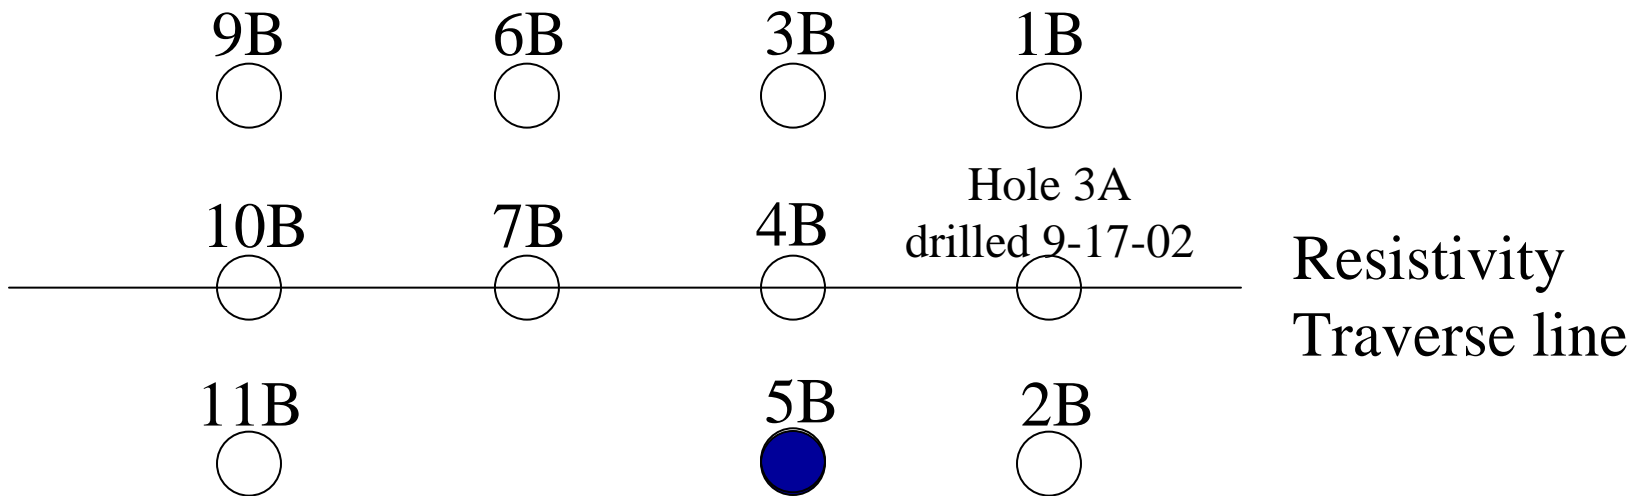
**Hole 5B – 60’ deep**

0-17      clay  
17-60    solid (water at 50’)

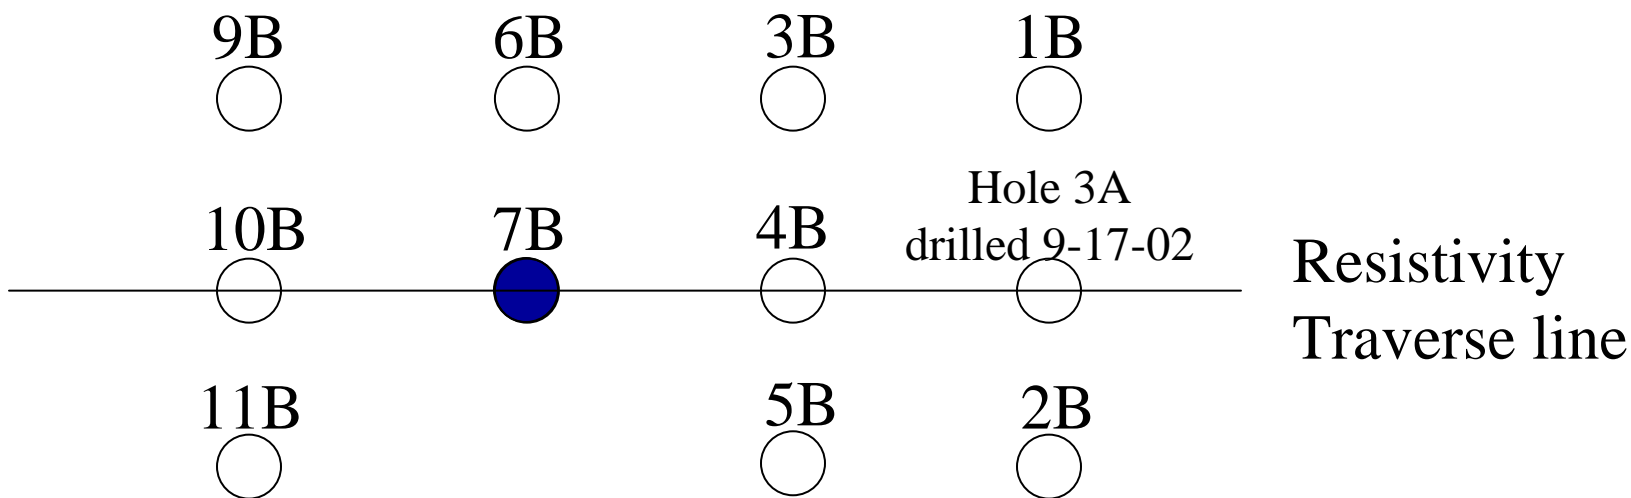
**Hole 7B – 60' deep**

0-13	clay
13-26	solid
26-36	open (water at 30')
36-60	solid

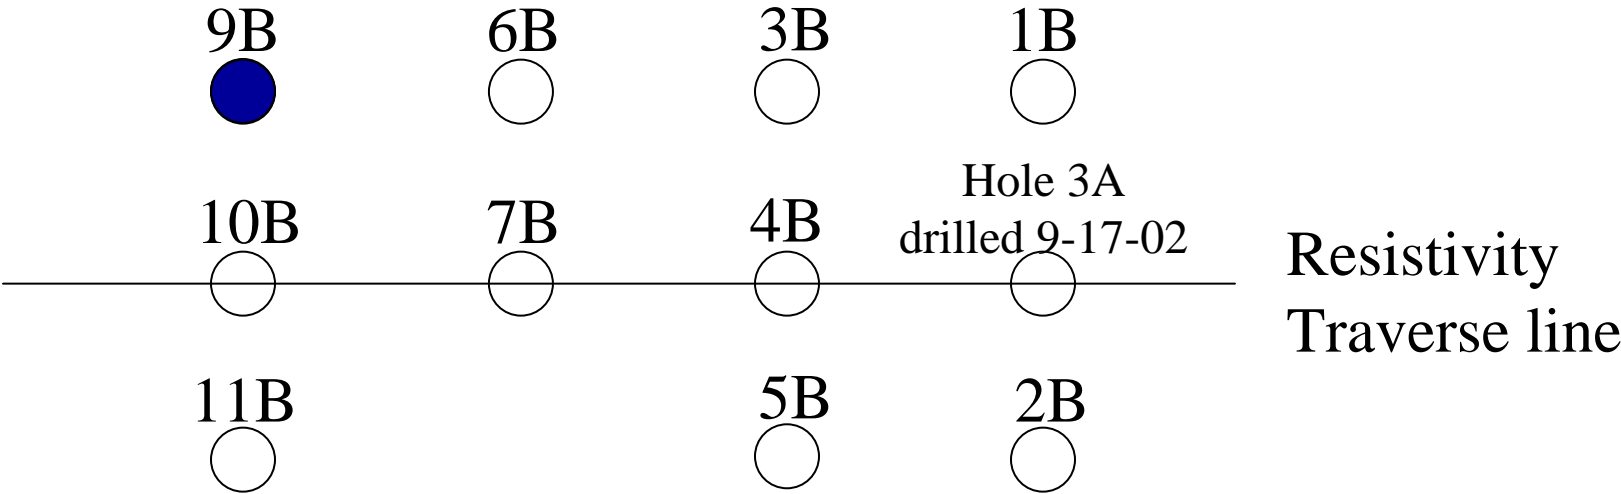
**Hole 9B – 60’ deep**

0-6      clay  
6-60     solid

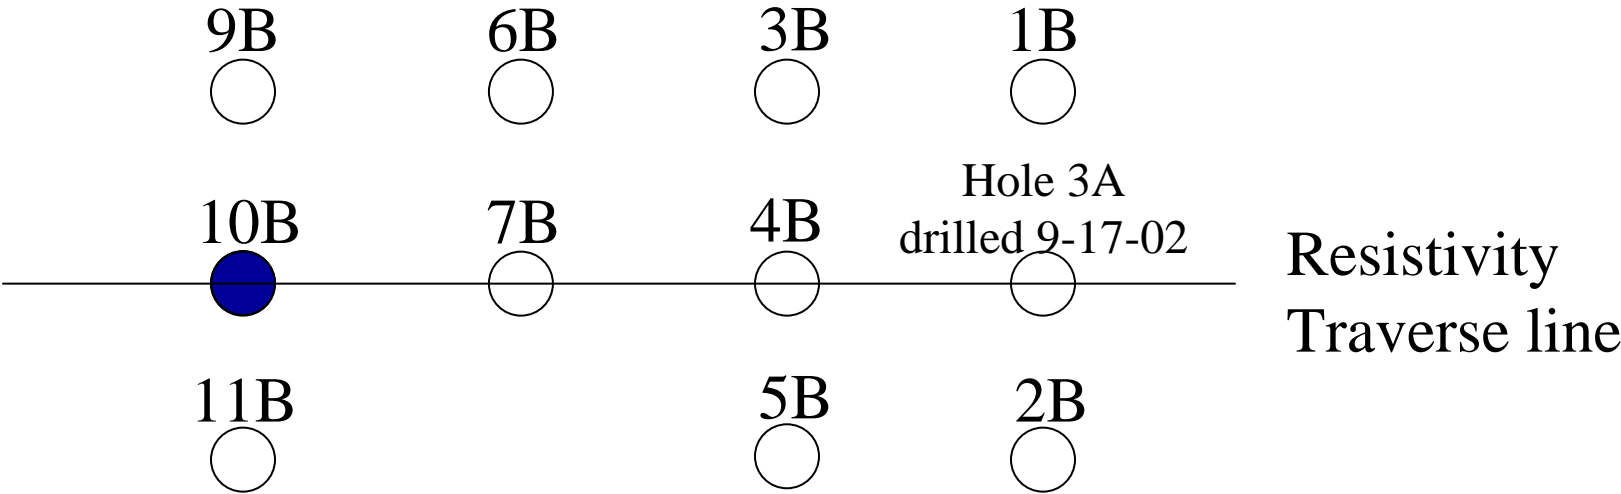
**Hole 10B – 60’ deep**

- 0-11      clay
- 11-30    solid (water at 30’)
- 30-39    open
- 39-60    solid

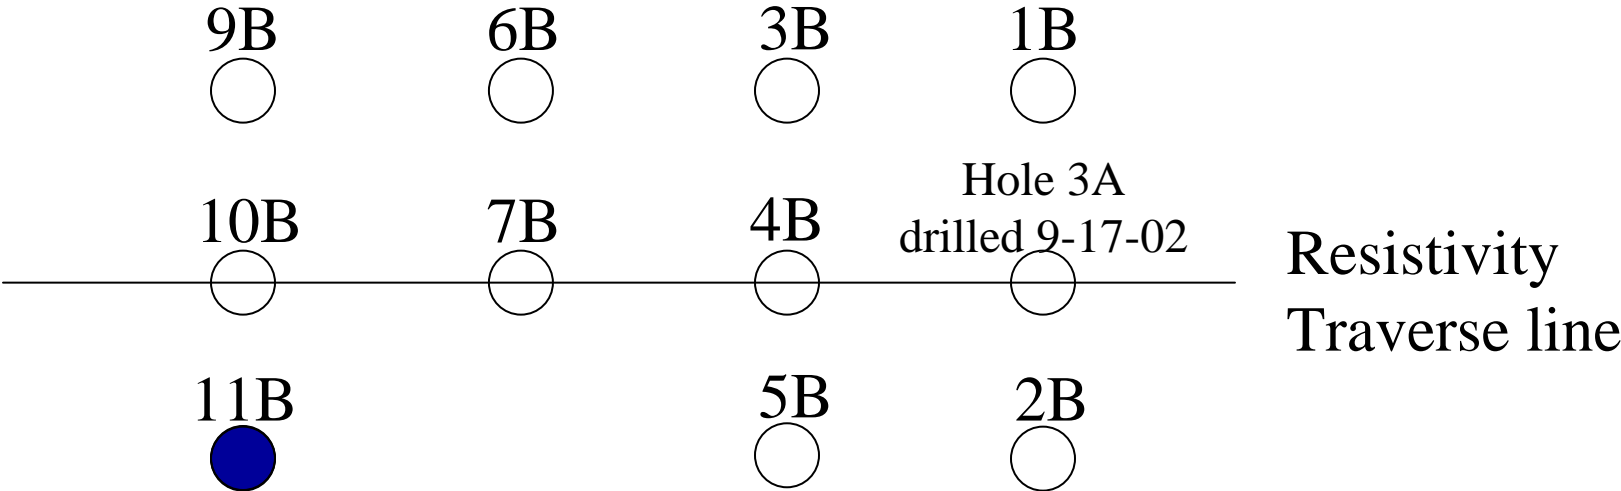
**Hole 11B – 60’ deep**

0-11     clay  
11-60    solid
